# The sacrifice of Insertion/Extractor Tool 96-1132 when inserting a Micro BNC Connector using excessive force

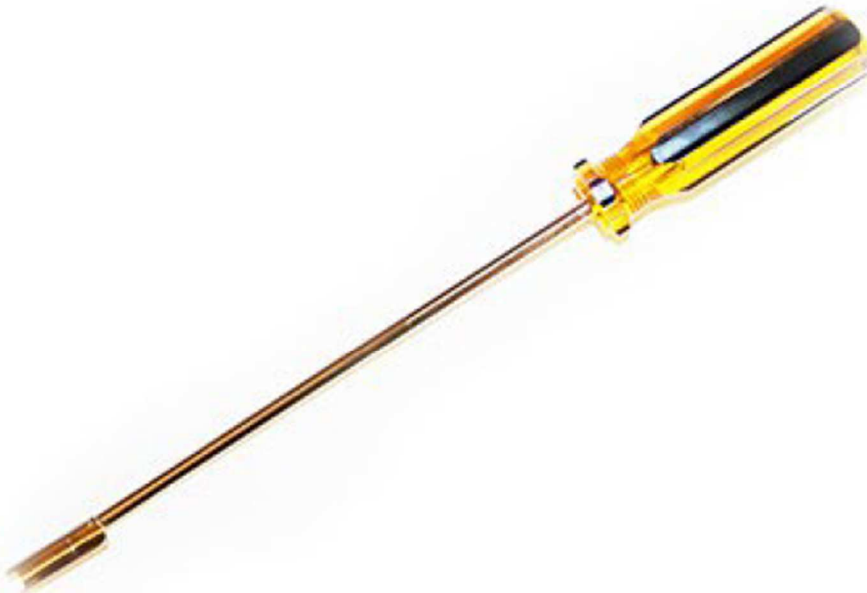
COAX Connectors' Micro BNC 75-ohm insertion and extraction tool 96-1132 has been developed for use when connectors are closely mounted, and finger access is not possible. The tool locates on a slot on the back of the connector body for simple insertion and extraction. In the event of excessive force being applied to the Micro BNC Connector Jack COAX's tool has been designed to break, saving the Micro BNC Connector Jack embedded within the more expensive equipment. COAX Connectors had experienced several reports of their Insert/Extractor Tool 96-1132 breaking in use, so the company was keen to address the reasons behind why this occurs.

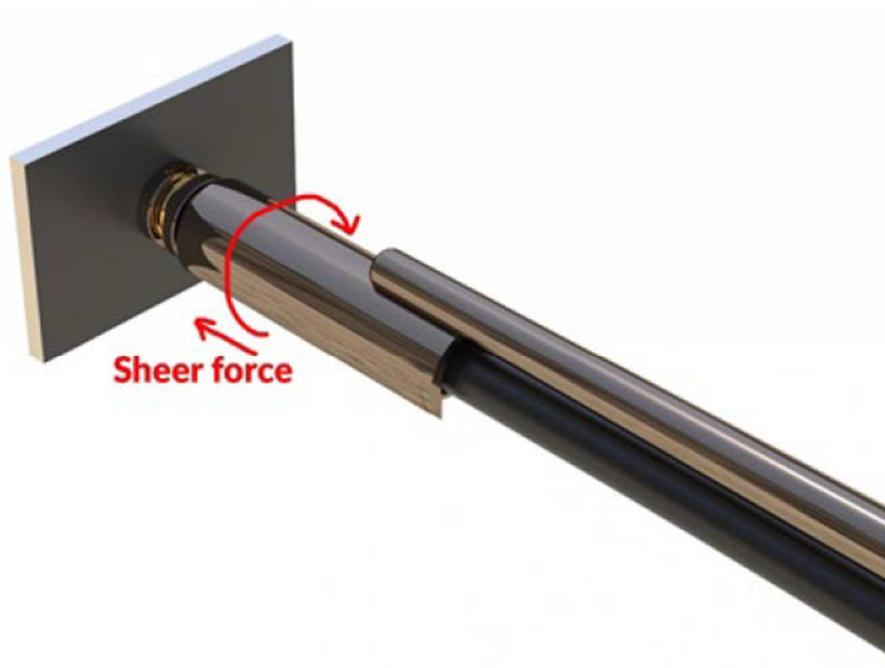
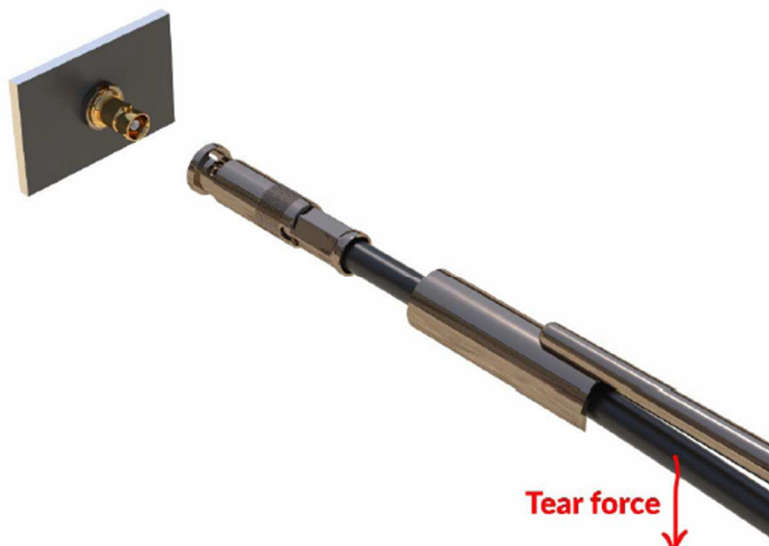
Testing and computerised simulation involved the following COAX parts: Micro BNC Bulkhead Jack  
Micro BNC Plug and Insertion/Extractor Tool

Testing was carried out with increasing amounts of shear force applied to the connectors with and without the Insertion/Extraction Tool. The objective of this was to establish the maximum force which could be applied to the connectors using the Tool without breakage of any of the parts occurring.

In addition to physical testing, using Solidworks an express simulation was run with static loads applied to the body of the Micro BNC. Simulations were run to show where the forces are concentrated under various load conditions.

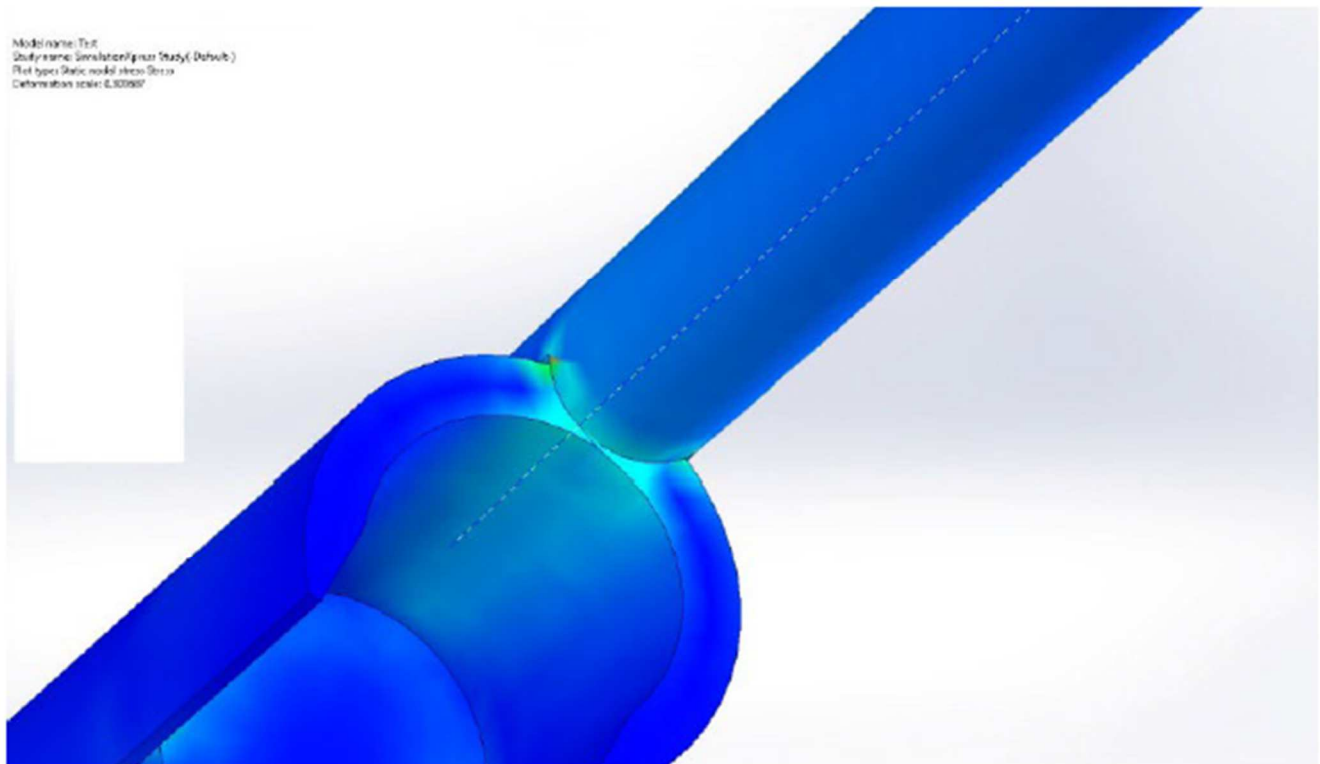
0.8 Newton Metres was reached the tool broke. The computerised stress test images 1 and 2 below show in red shows the joint eventually ripping on the tool.

Image 1 – Solidworks stress test simulation highlighting where tooling would fail with excessive force.

It is essential that insertion/extractor tooling is manufactured to withstand less force than the connectors to avoid damage to the connectors installed within expensive equipment. In testing it has been proven that COAX's Insertion/Extractor Tool (96-1132) will be sacrificed to save the connectors in this case Micro BNC bulkhead jack 67-461-1-D66 in the event of more than 0.8 Newton Metres sheer force being applied to it. This breakage at 0.8 Newton Metres of sheer force will mean that the 1.0 Newton Metres force limit of the connectors will not be reached, and the connectors will remain intact. All of COAX's Insertion/Extractor Tools for use with Micro BNC Connectors are constructed in the same way to sacrifice the tool and not the connector in the event of excessive force being applied.

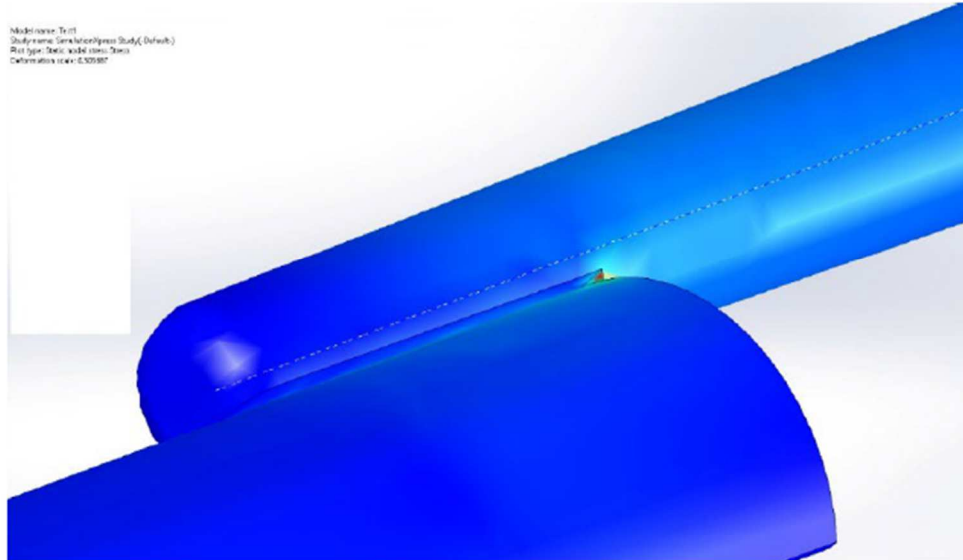
Image 2 - Solidworks stress test simulation highlighting where tooling would fail with excessive force.

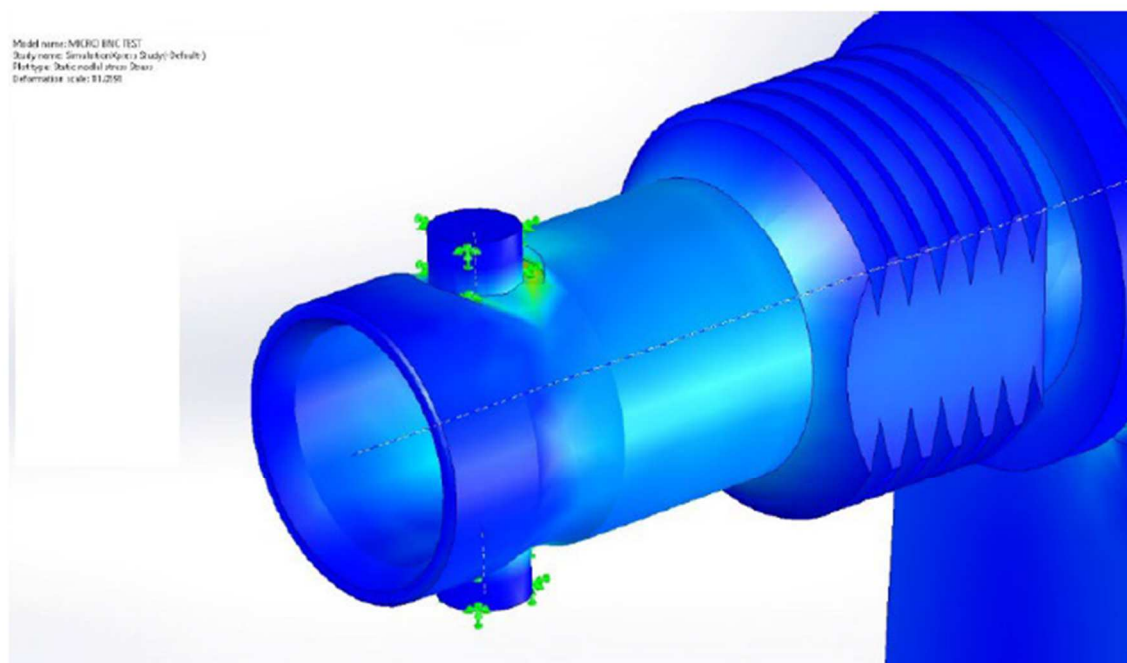
The body of the Micro BNC bulkhead jack 67-461-1-D66 had an increasing amount of force applied to it, to see where it would eventually fail, and this was at 1.0 Newton Metres of shear force. See images 3 and 4 below. Image 3 shows where breakage would eventually occur and photo image 4 shows the damage that would be done to the connectors if the tool was made stronger than the connectors.

Image 3 - Stress test simulation highlighting where breakage would occur on Micro BNC bulkhead connector with excessive tooling force.

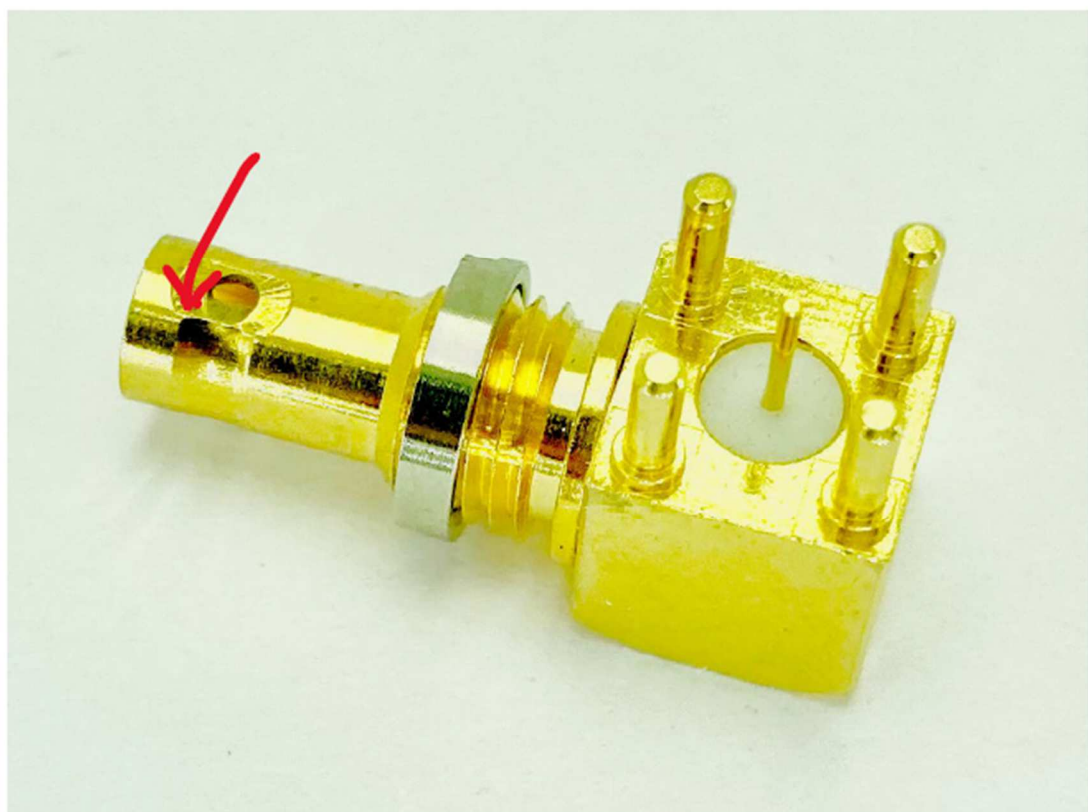
Image 4 – Photograph demonstrating where on connector breakage occurs with more than 1.0 Newton Metres of sheer force applied.
